Volunteer Evaluation of Prototype Integrated Wheelchair Seating Stations with UDIG-Compatible Docking Systems and Automated Belt Donning

Nichole R. Orton, Miriam A. Manary, Kyle J. Boyle, Brian Eby, Jennifer Bishop, Jingwen Hu, Kathleen D. Klinich
Biosciences Group, University of Michigan Transportation Research Institute

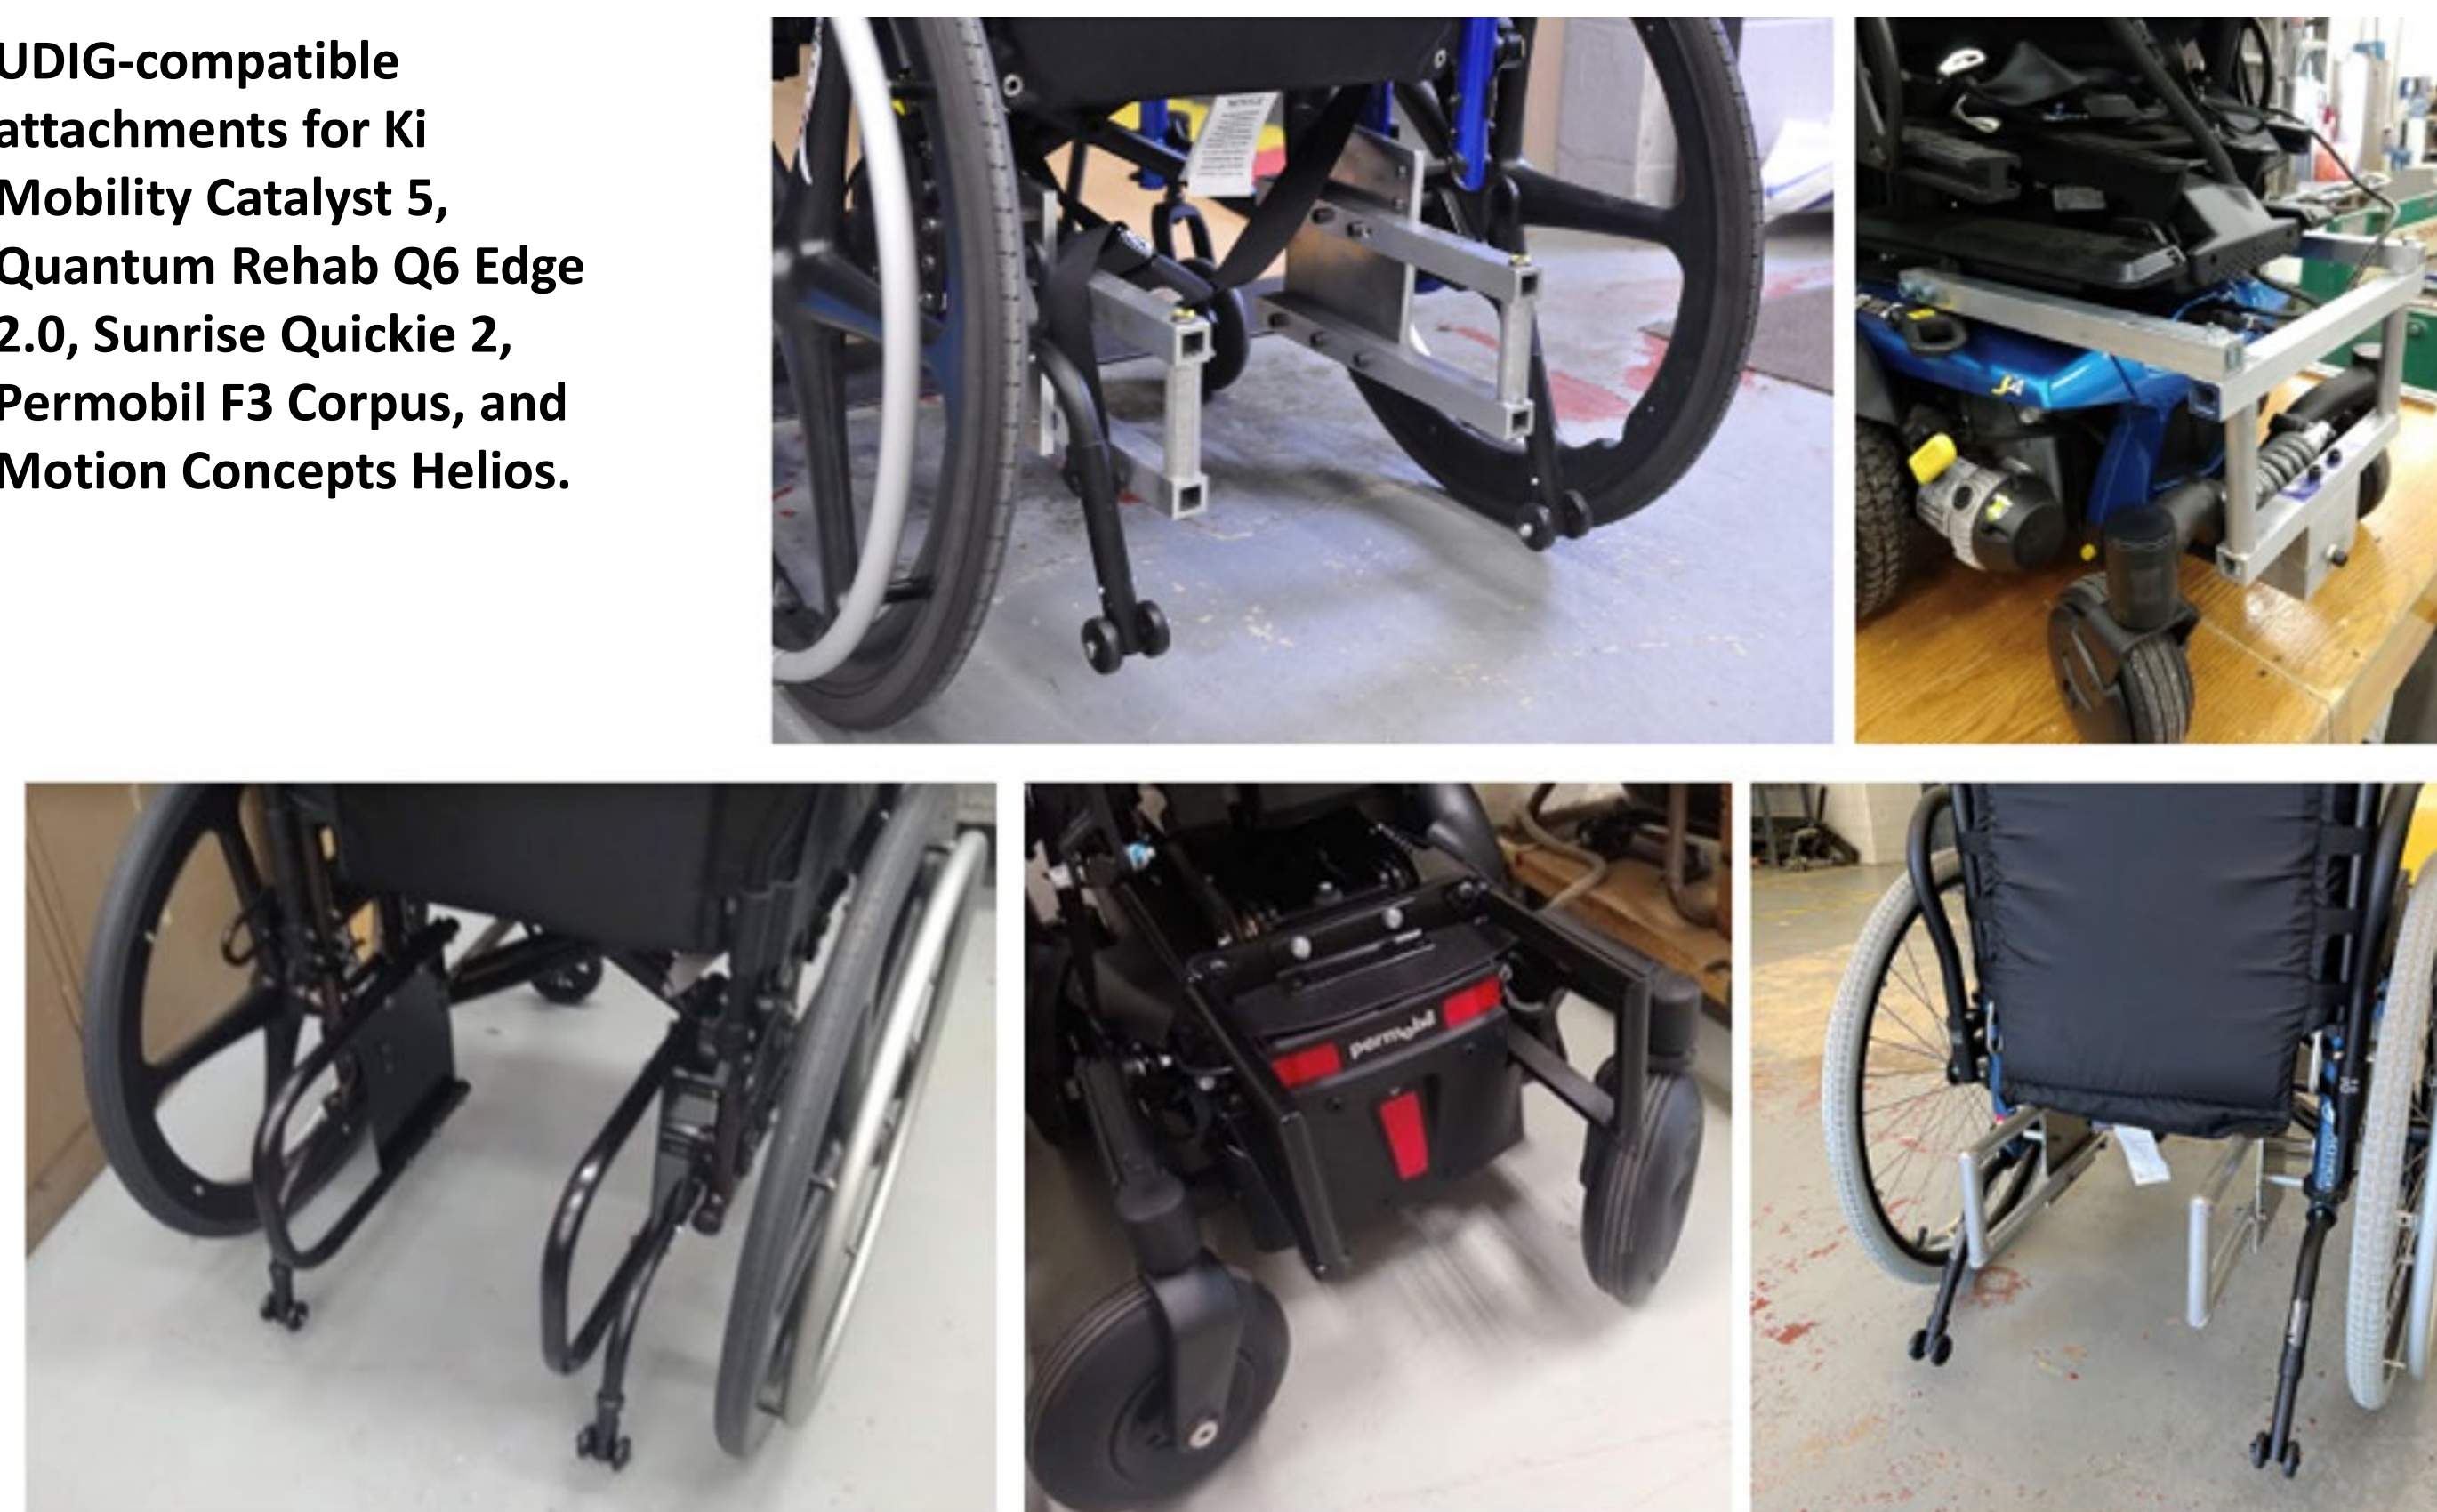
WHEELCHAIR ATTACHMENTS

UDIG-compatible attachments for Ki Mobility Catalyst 5, Quantum Rehab Q6 Edge 2.0, Sunrise Quickie 2, Permobil F3 Corpus, and Motion Concepts Helios.

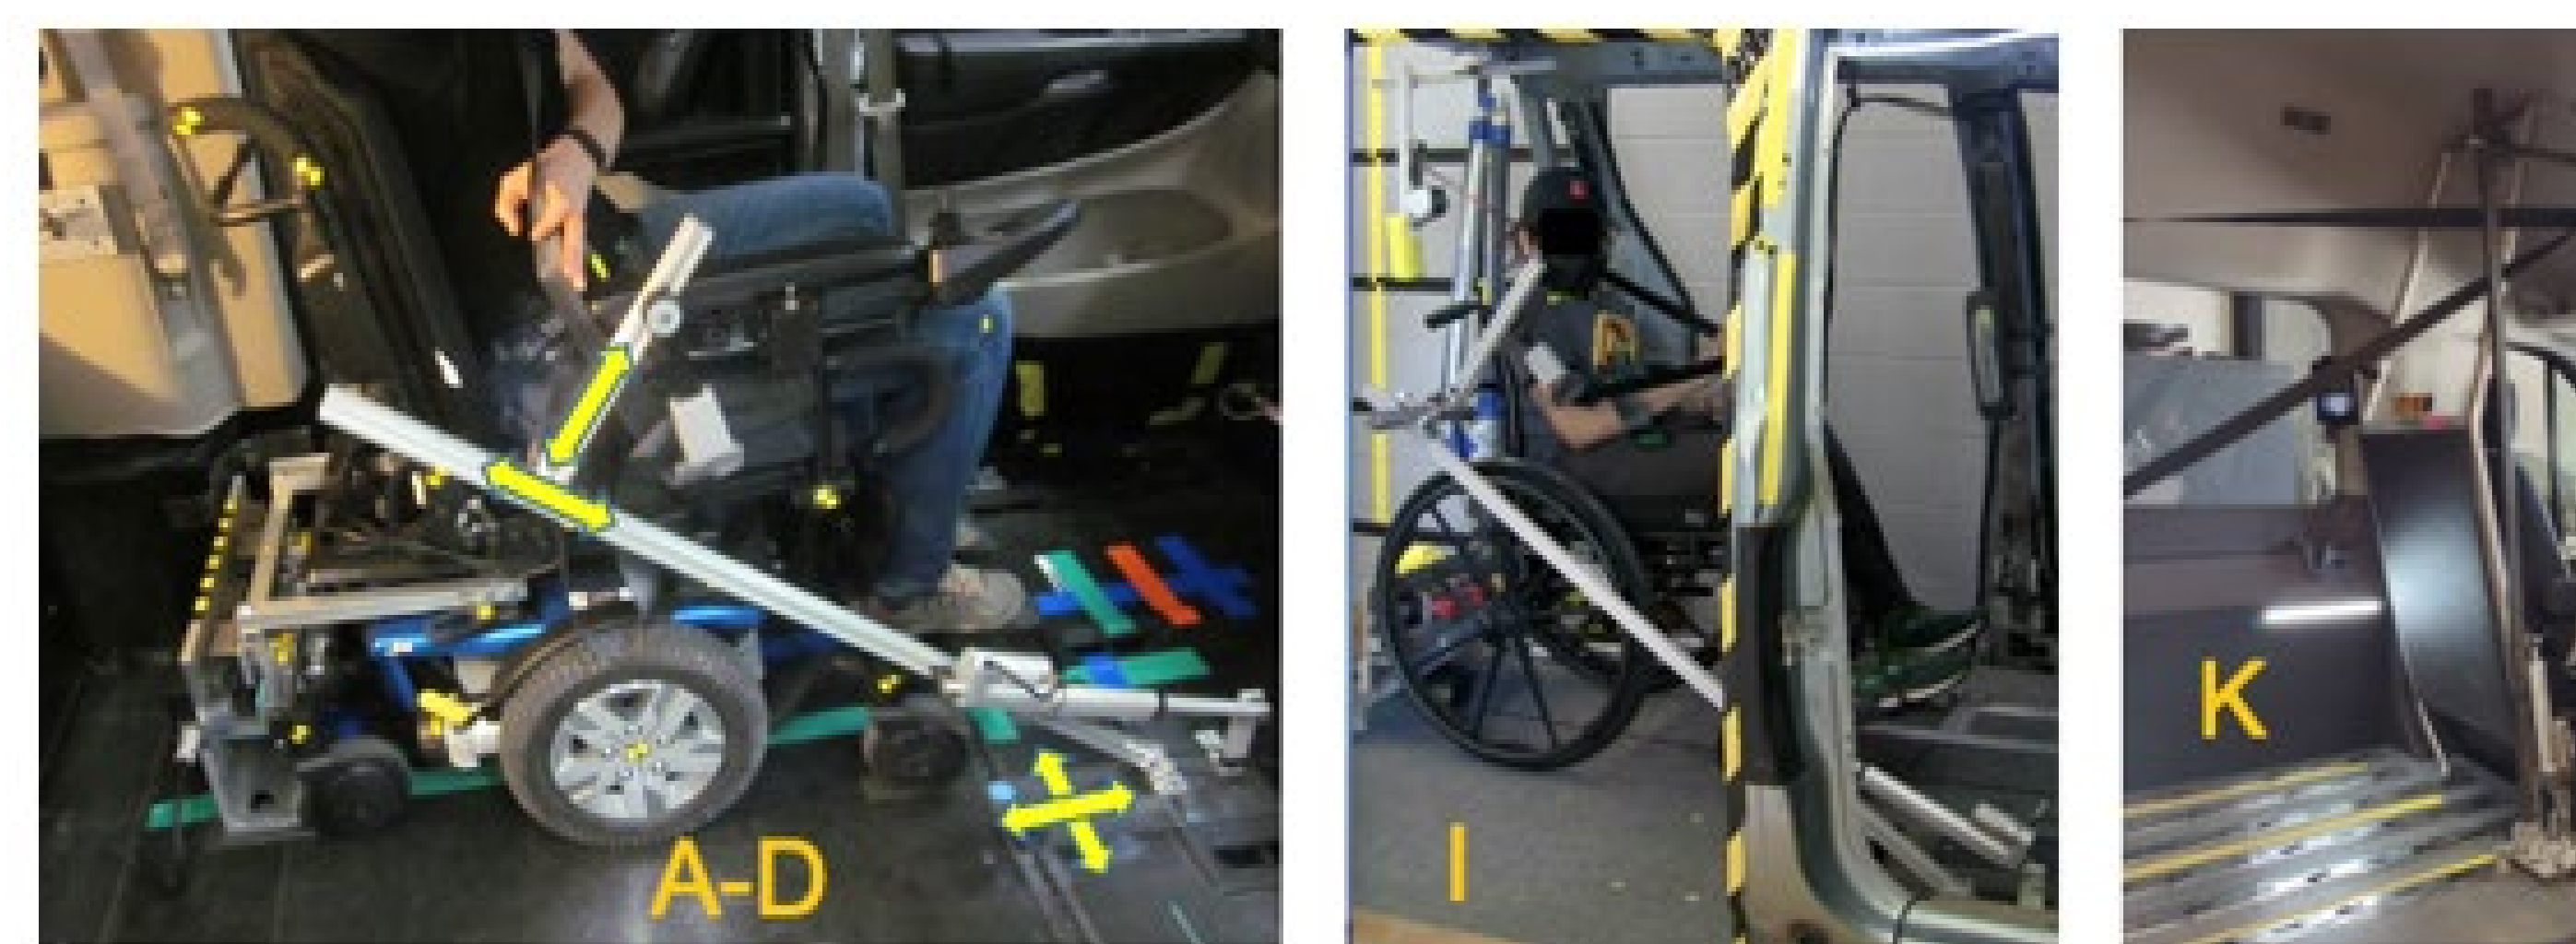
AUTOMATED DONNING ARMS

Donning arms used in conditions A-D, I, and K

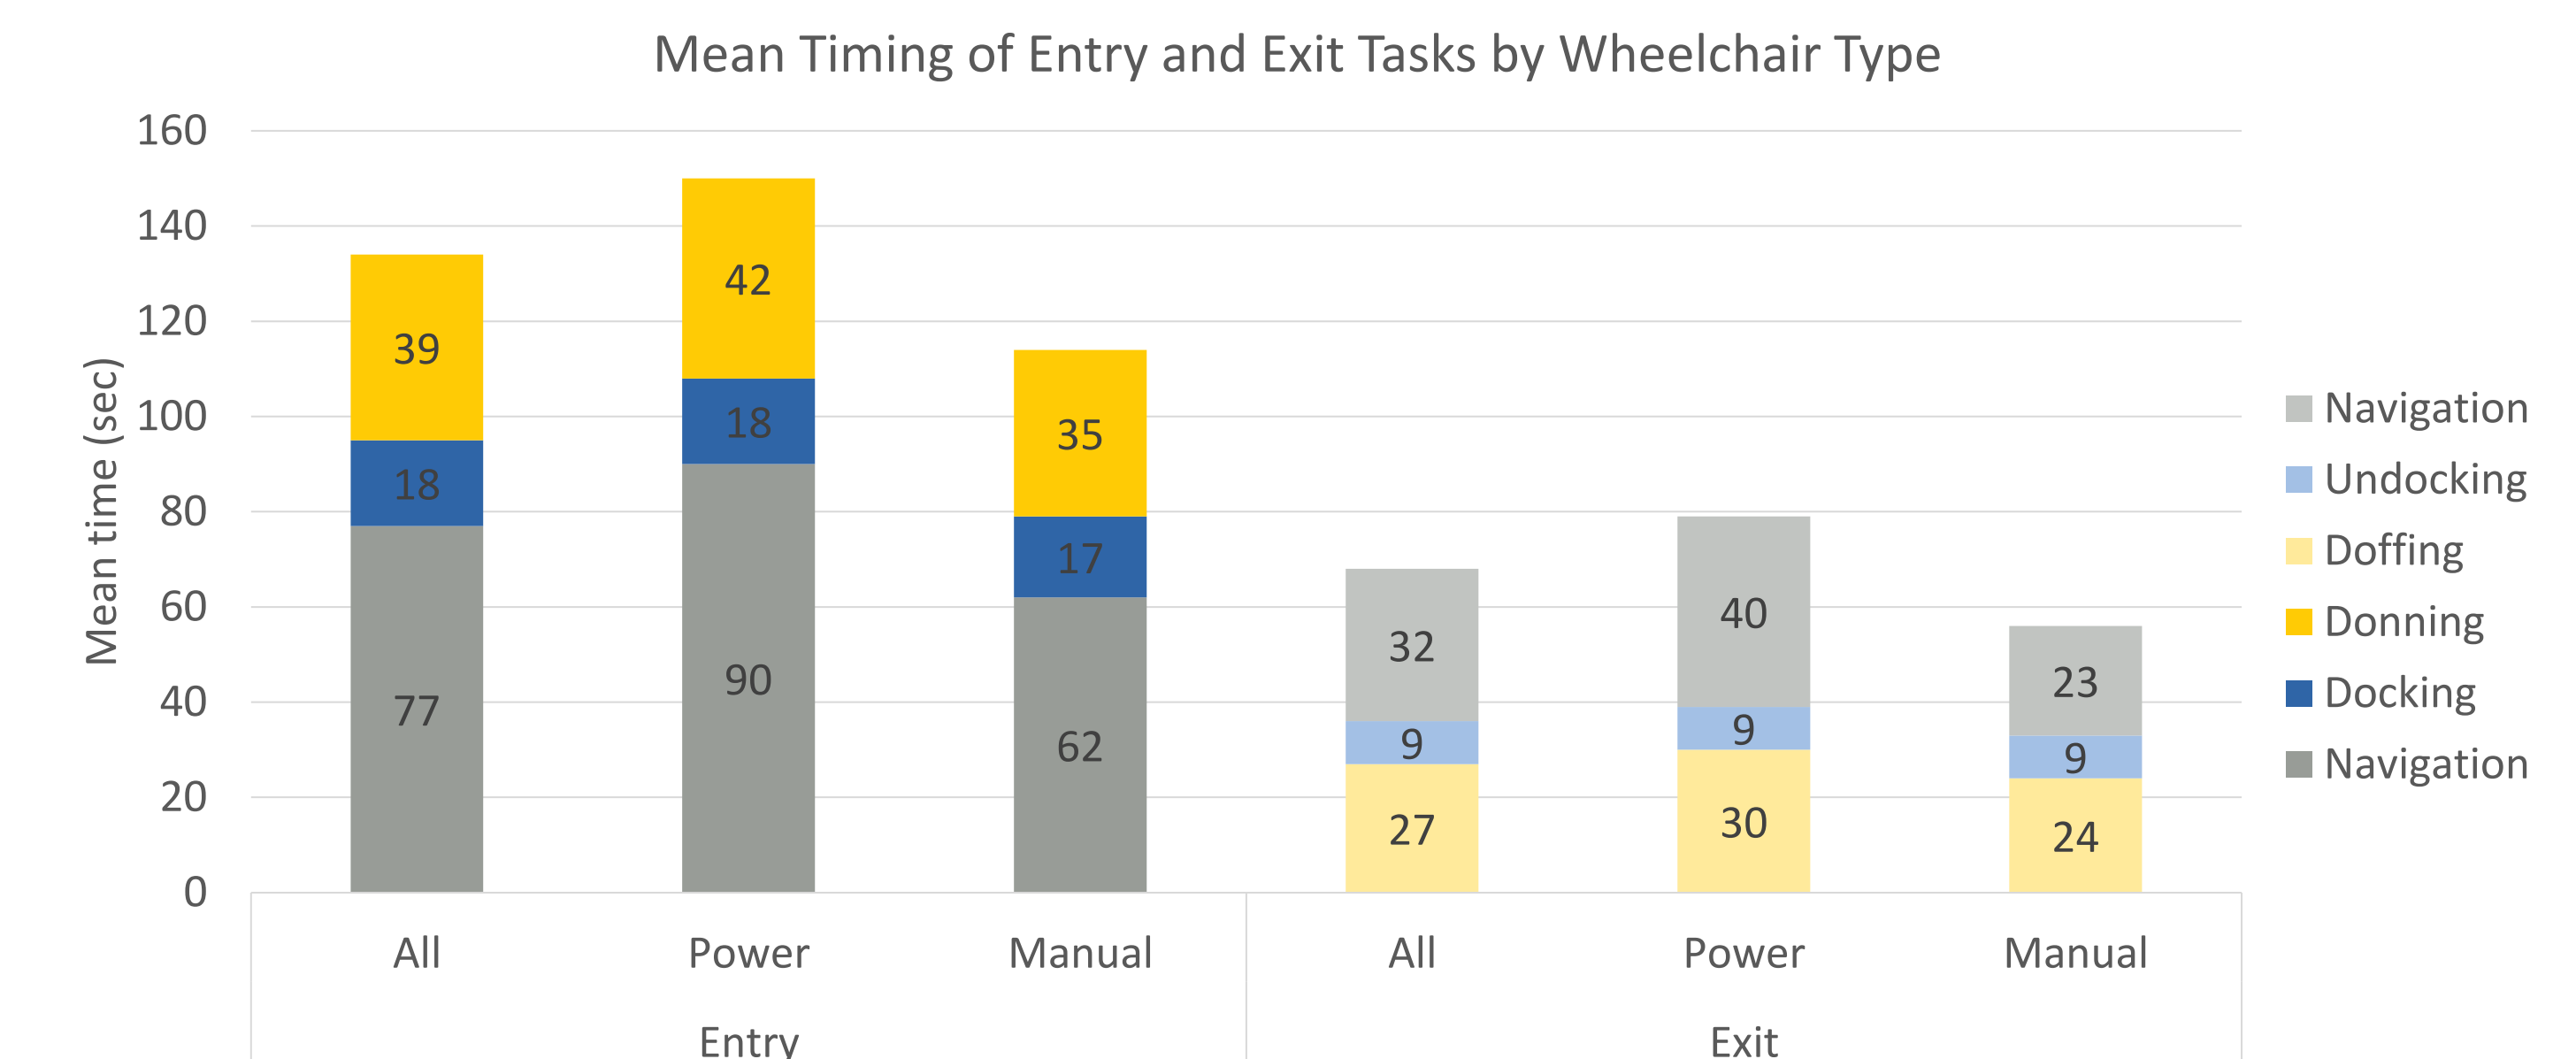
Across all studies, all volunteers were able to successfully secure the study wheelchairs in every trial. Times were longer for trials in power wheelchairs compared to manual, likely because they were longer than the manual wheelchairs and more challenging to maneuver, and because more of our participants were regular manual wheelchair users and less familiar with operating a power wheelchair.
